New York State Department of Transportation

Yellow Flag NB22CTW013

BIN: 1065318

Feature Carried: 278I278IX2M23027

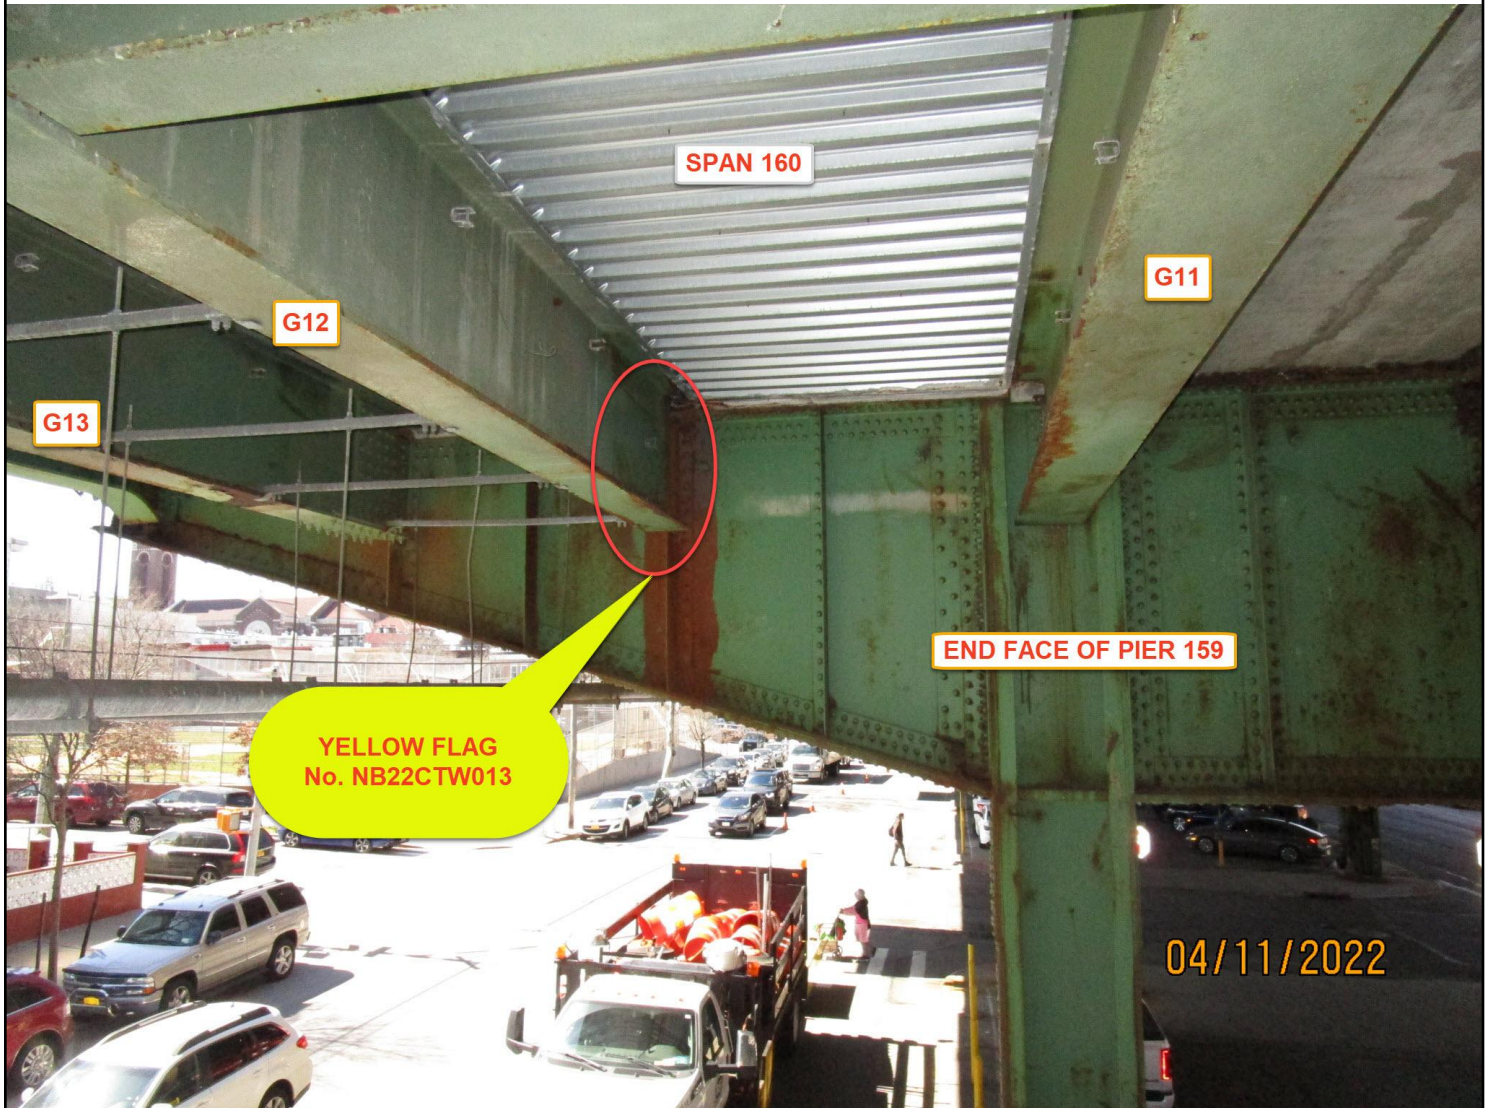
Photo Number: 1

Attachment Description: Span 160 G12 at Pier 159, Looking Begin. General view of the flagged location that exhibits 3" long crack in the bottom of the connection angle of the girder to the pier web.

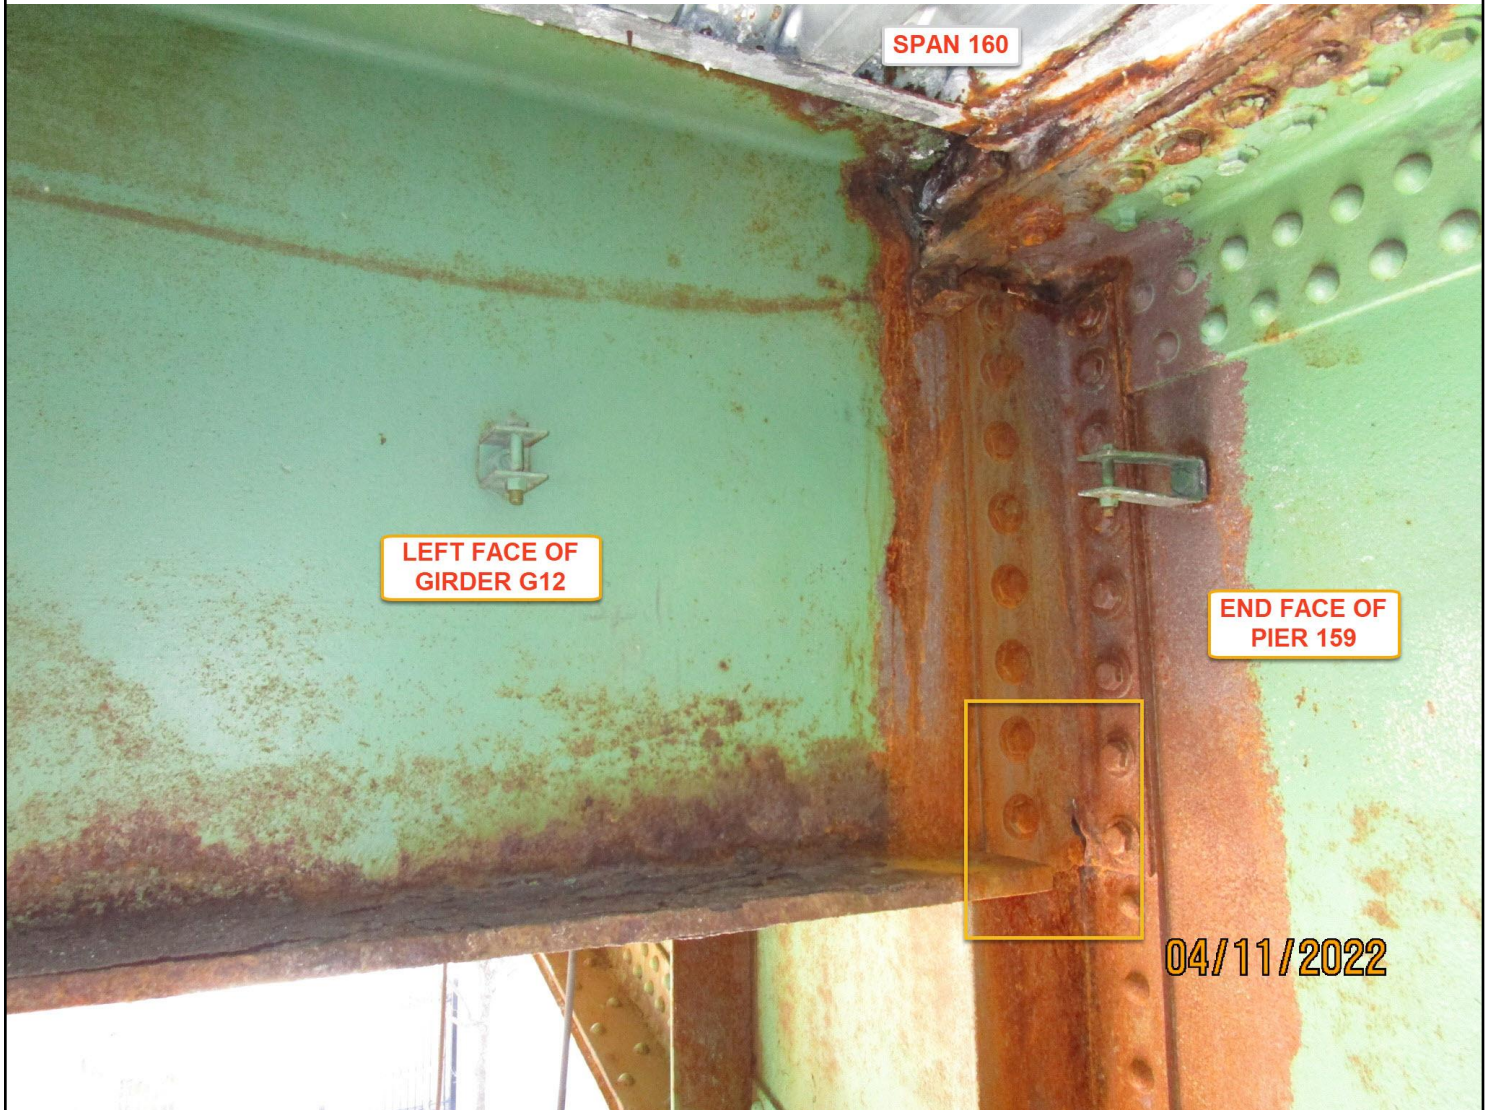
Photo Number: 2

Description: The left connection angle for Girder G12 in Span 160 to Pier 159 exhibits a 3" long (no change from previous) crack at the bottom of the connection angle in the fillet area (Photo Nos. 2, 3 and 4). The end of Girder G12 itself exhibits moderate to heavy localized pitting in the lower web above the bottom flange with up to 25% section loss (no change from previous).

Attachment Description: Span 160 G12 at Pier 159, Looking Begin-Right. General view of the flagged location that exhibits 3" long crack in the bottom of the connection angle of the girder to the pier web.

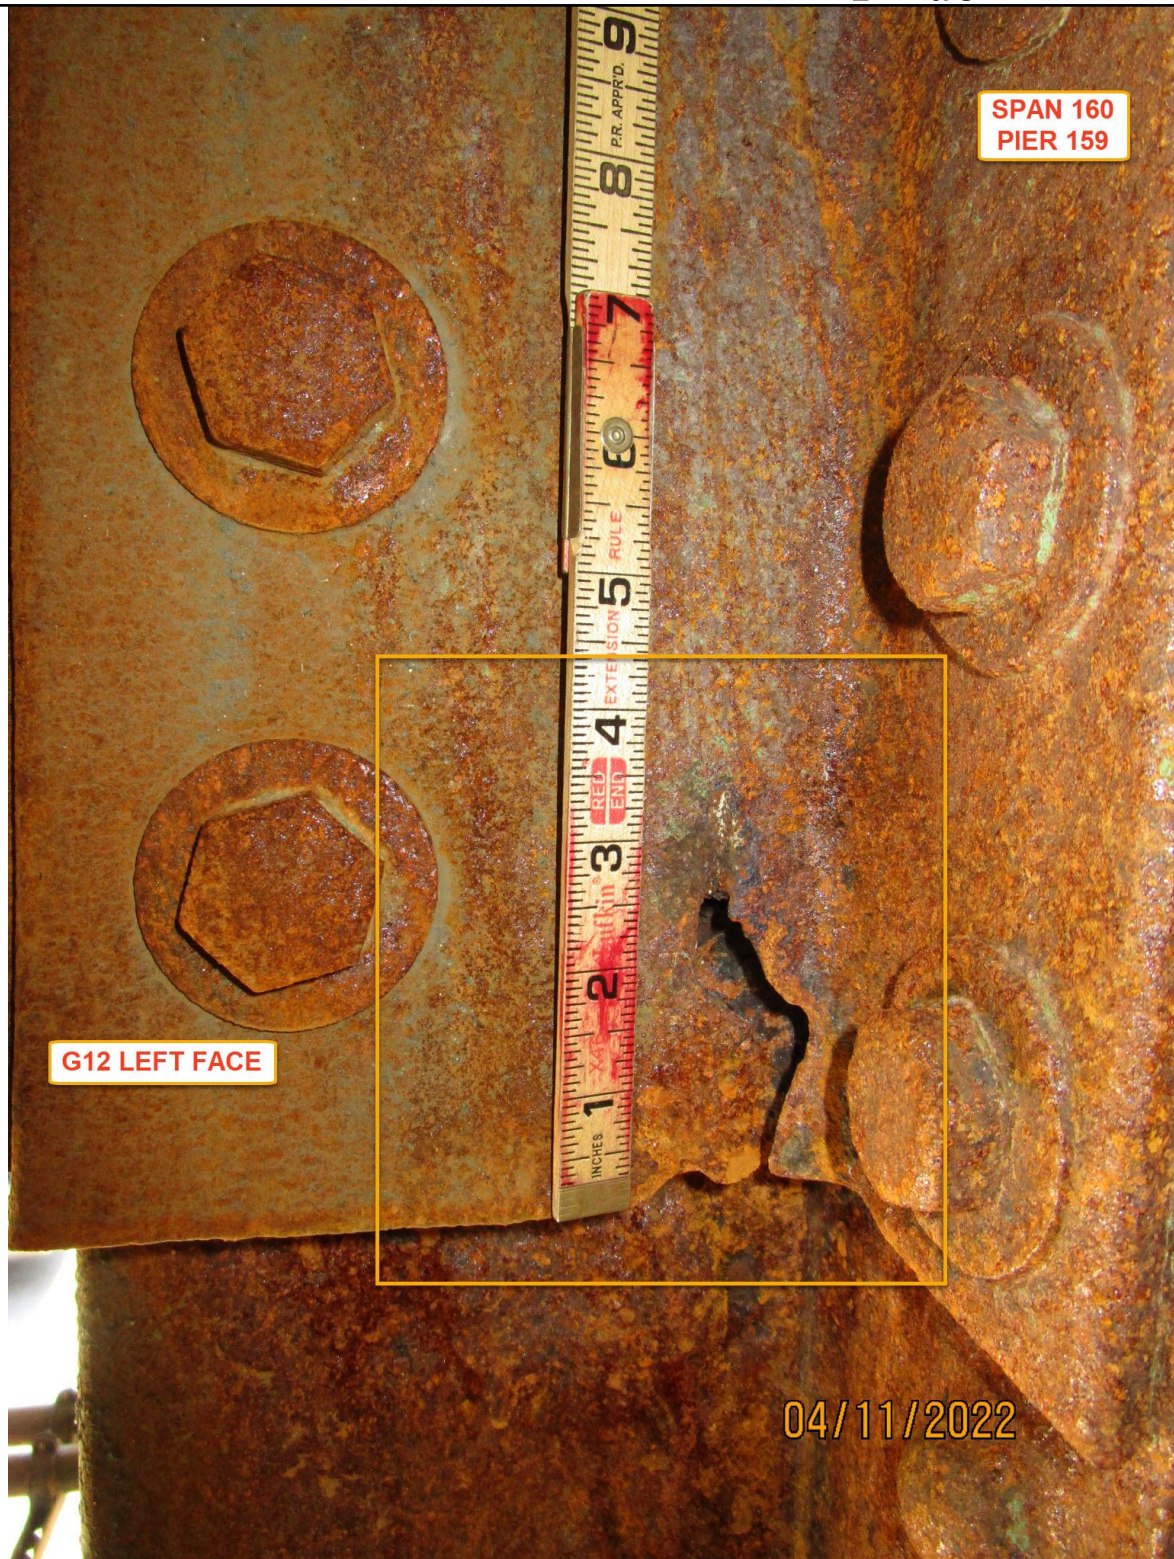
Photo Number: 3

Attachment Description: Span 160 G12 at Pier 159, Looking Right. Close up view of the 3" long crack at the bottom of the connection angle of the girder to the pier web.

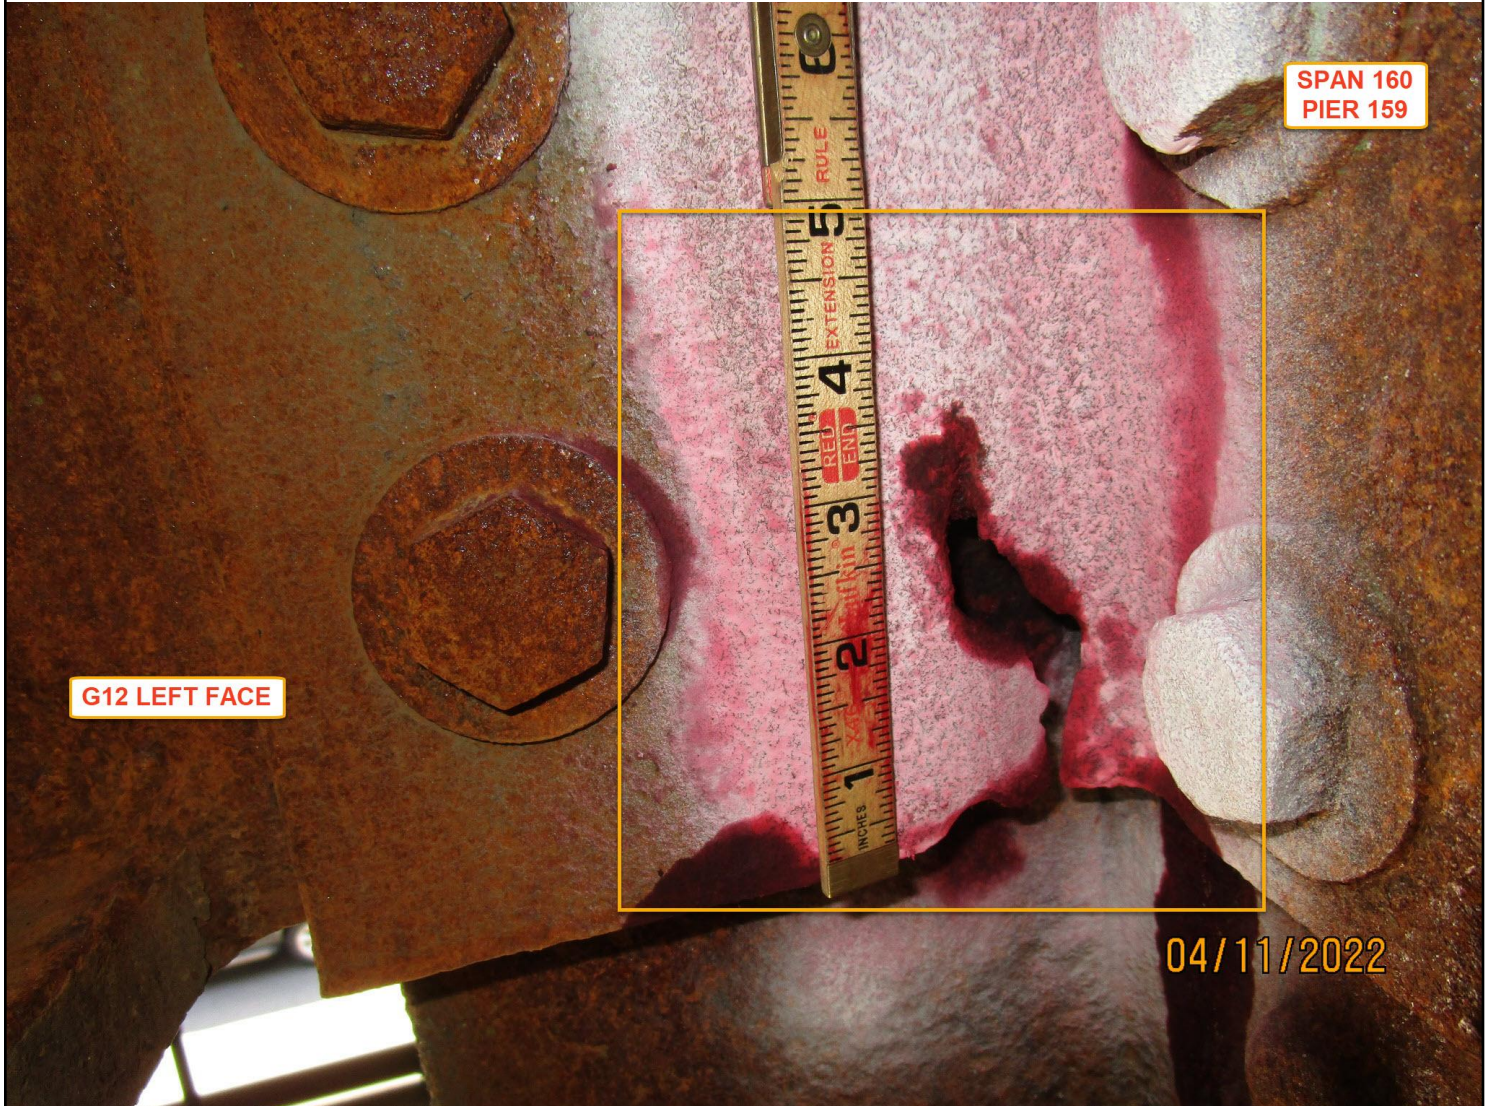
Photo Number: 4

A dye penetrant test was performed to determine the extent of the crack, which does not propagate into the base steel of the girder or pier web.

Attachment Description: Span 160 G12 at Pier 159, Looking Right. Close up view of the 3" long crack at the bottom of the connection angle of the girder to the pier web, after dye penetrant test.

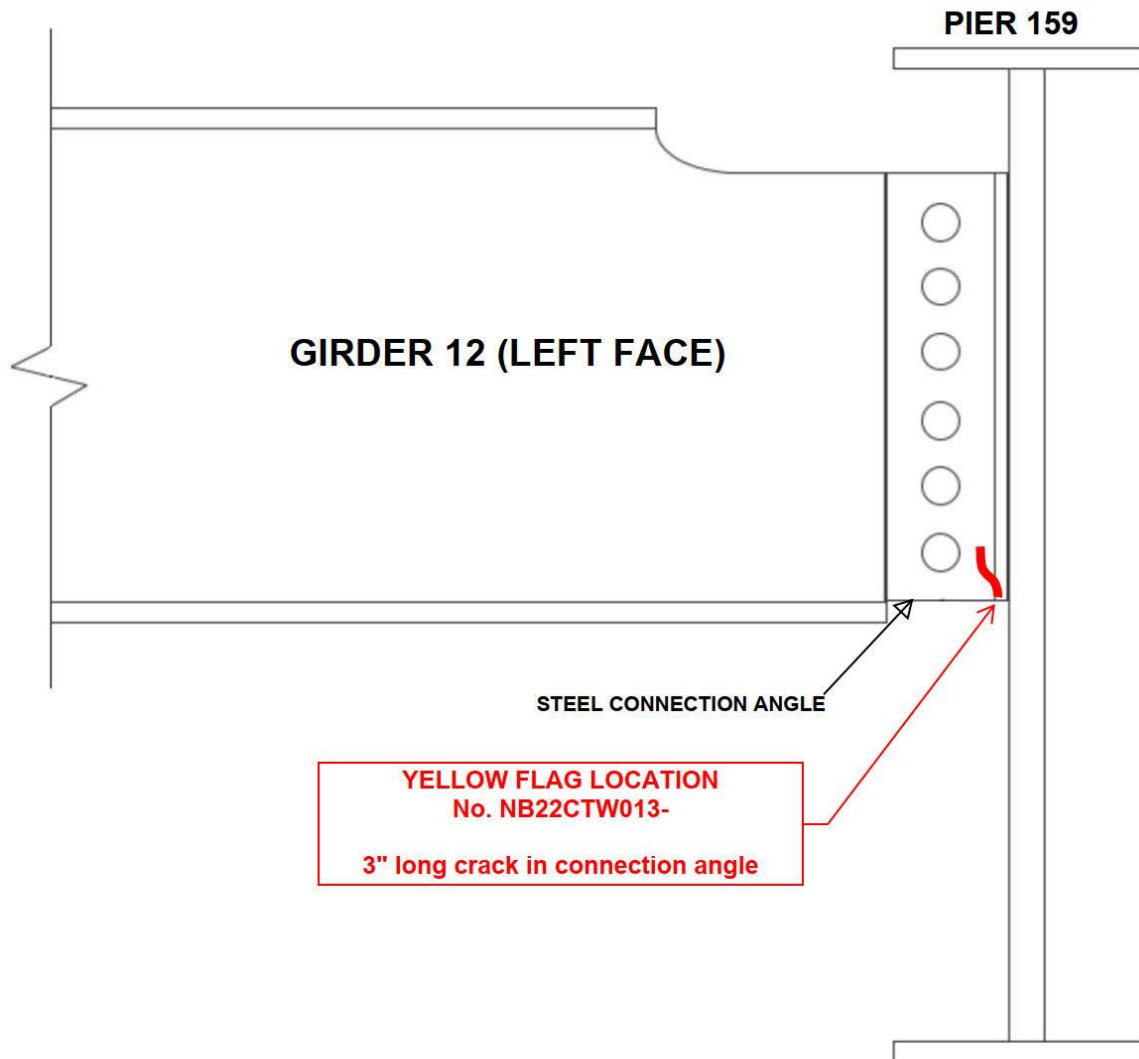
Photo Number: 5

**Attachment Description: SN 160 G12 at Pier 159 Sketch**

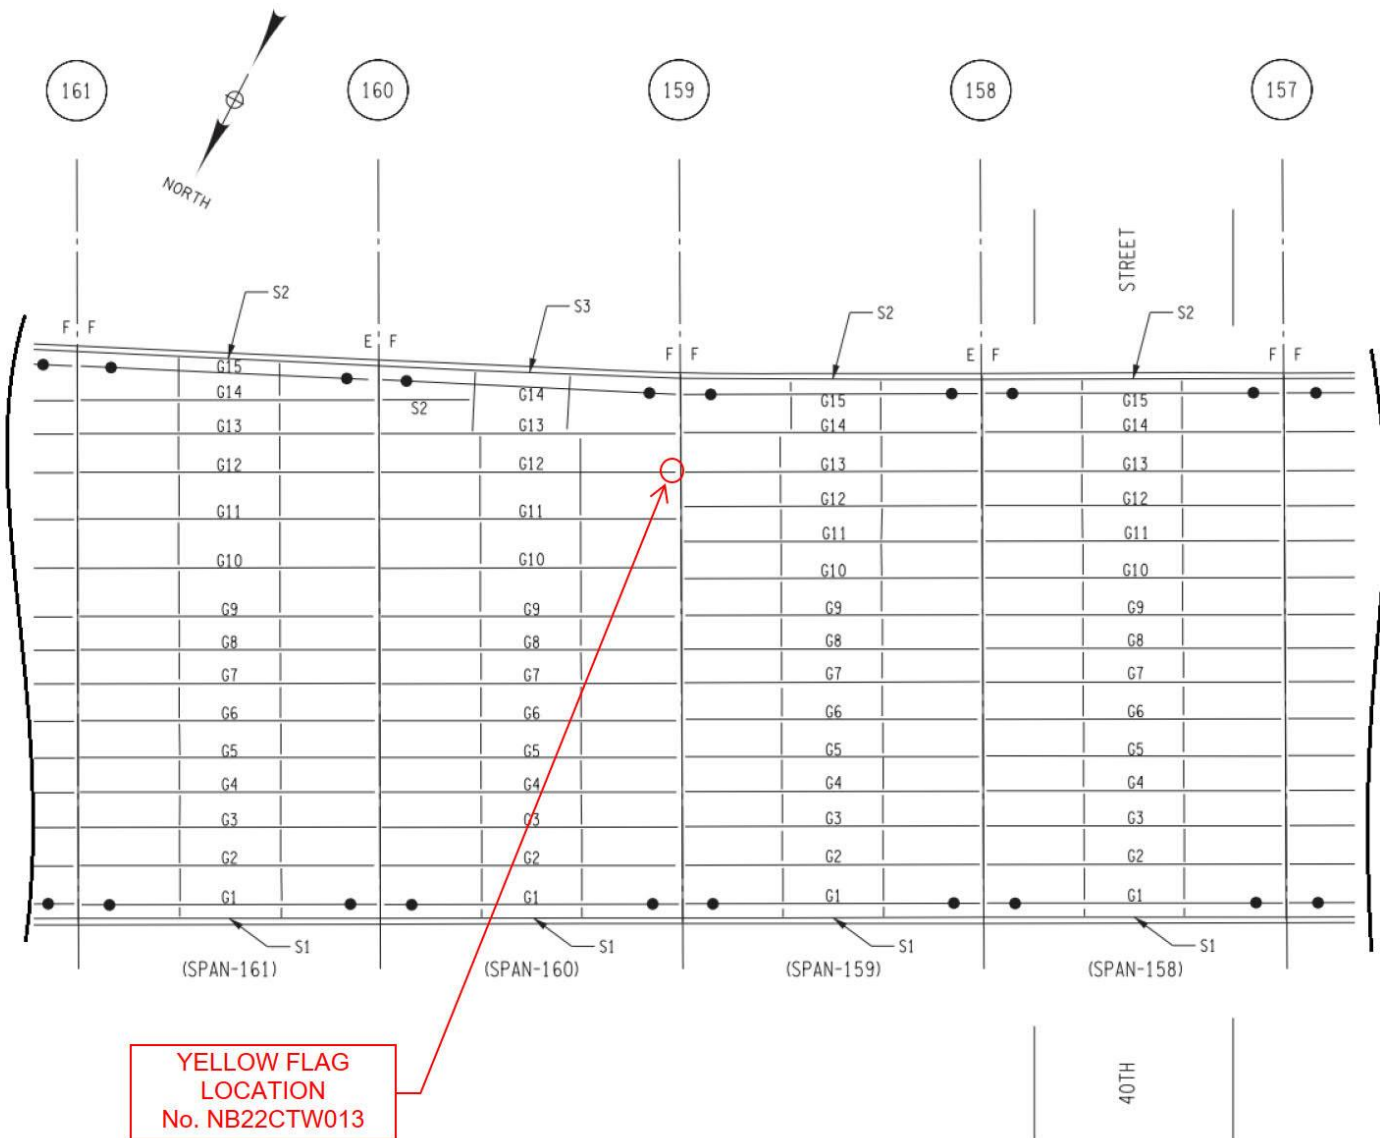
Photo Number: 6

Attachment Description: SN 160 G12 at Pier 159 Framing Plan
